# DAMAGE ASSESSMENT FORM

Building Name Redland Community Methodist Church

Address 24000 SW 187th AVE

Inspector(s) Alisa Block Agency/Team U.M./Hist. Pres. Date 9.11.92  
Photographs or Video (Roll and Numbers) \_\_\_\_\_

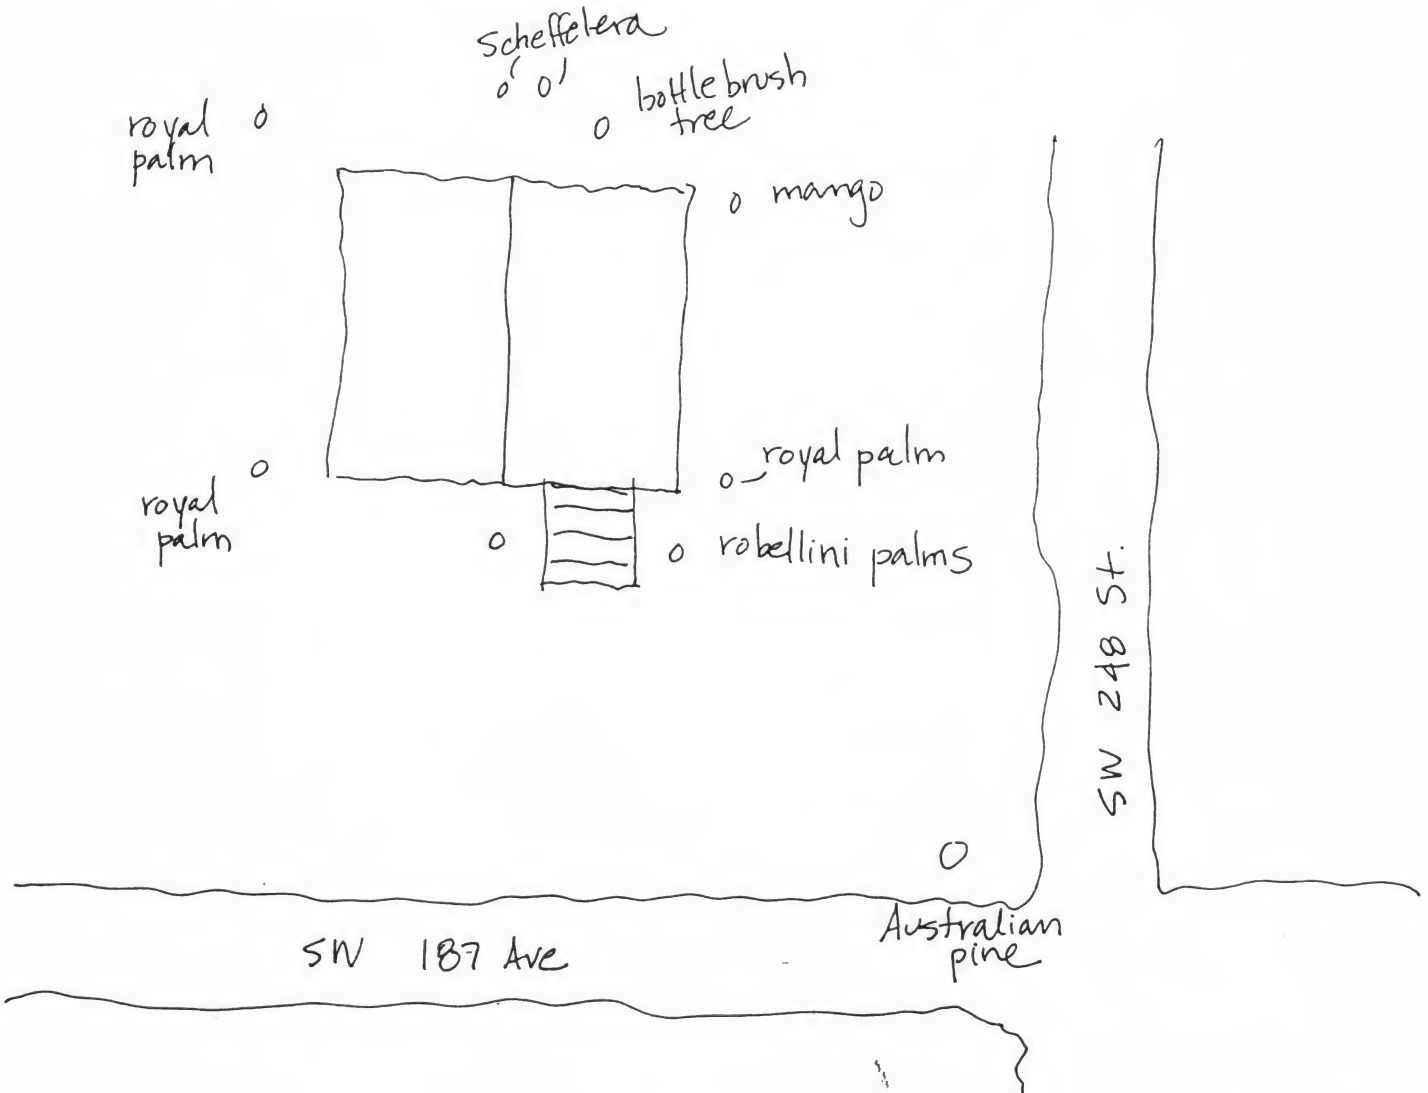
## Site Sketch:

- Comments:
- Most trees down
  - royal palms either missing top or down
  - robellini palms at entrance still standing
  - very few large trees on the site
